DAM INSPECTION CHECKLIST POSSUM POINT POWER STATION POND ABC

INSPECTION DATE: FEB 17, 2016

INSPECTED BY: K. ACREE

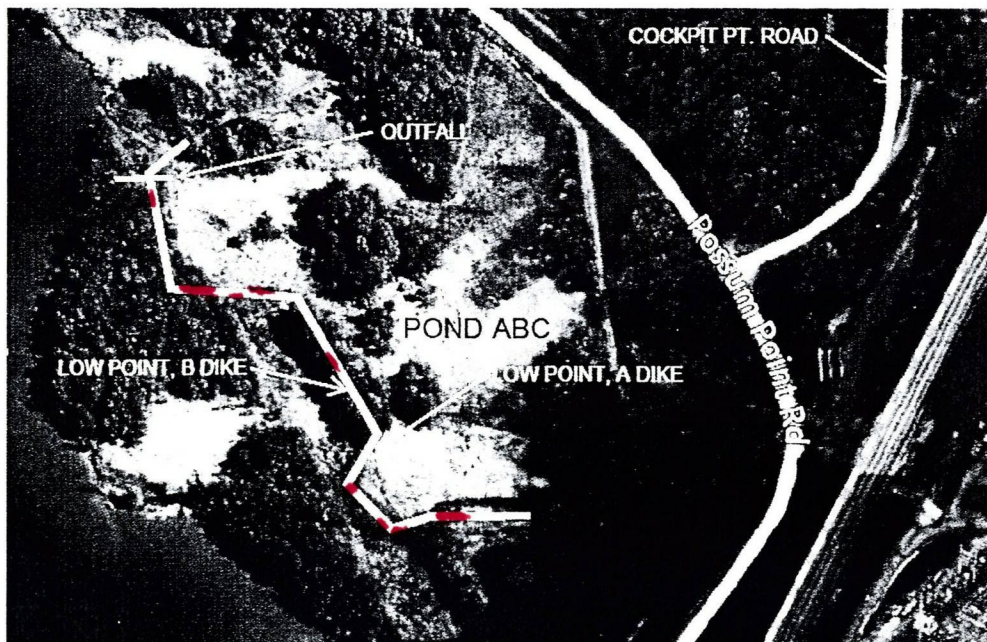
* See figure below.

→ STANDING WATER AT TOP OF EMBANKMENT OF PONDS B, B+B+C (SEE FIGURE BELOW, RED INDICATES STANDING WATER)
